New York State Department of Transportation

Yellow Flag NB22CTW010

BIN: 1065318

Feature Crossed: 6TH AVENUE

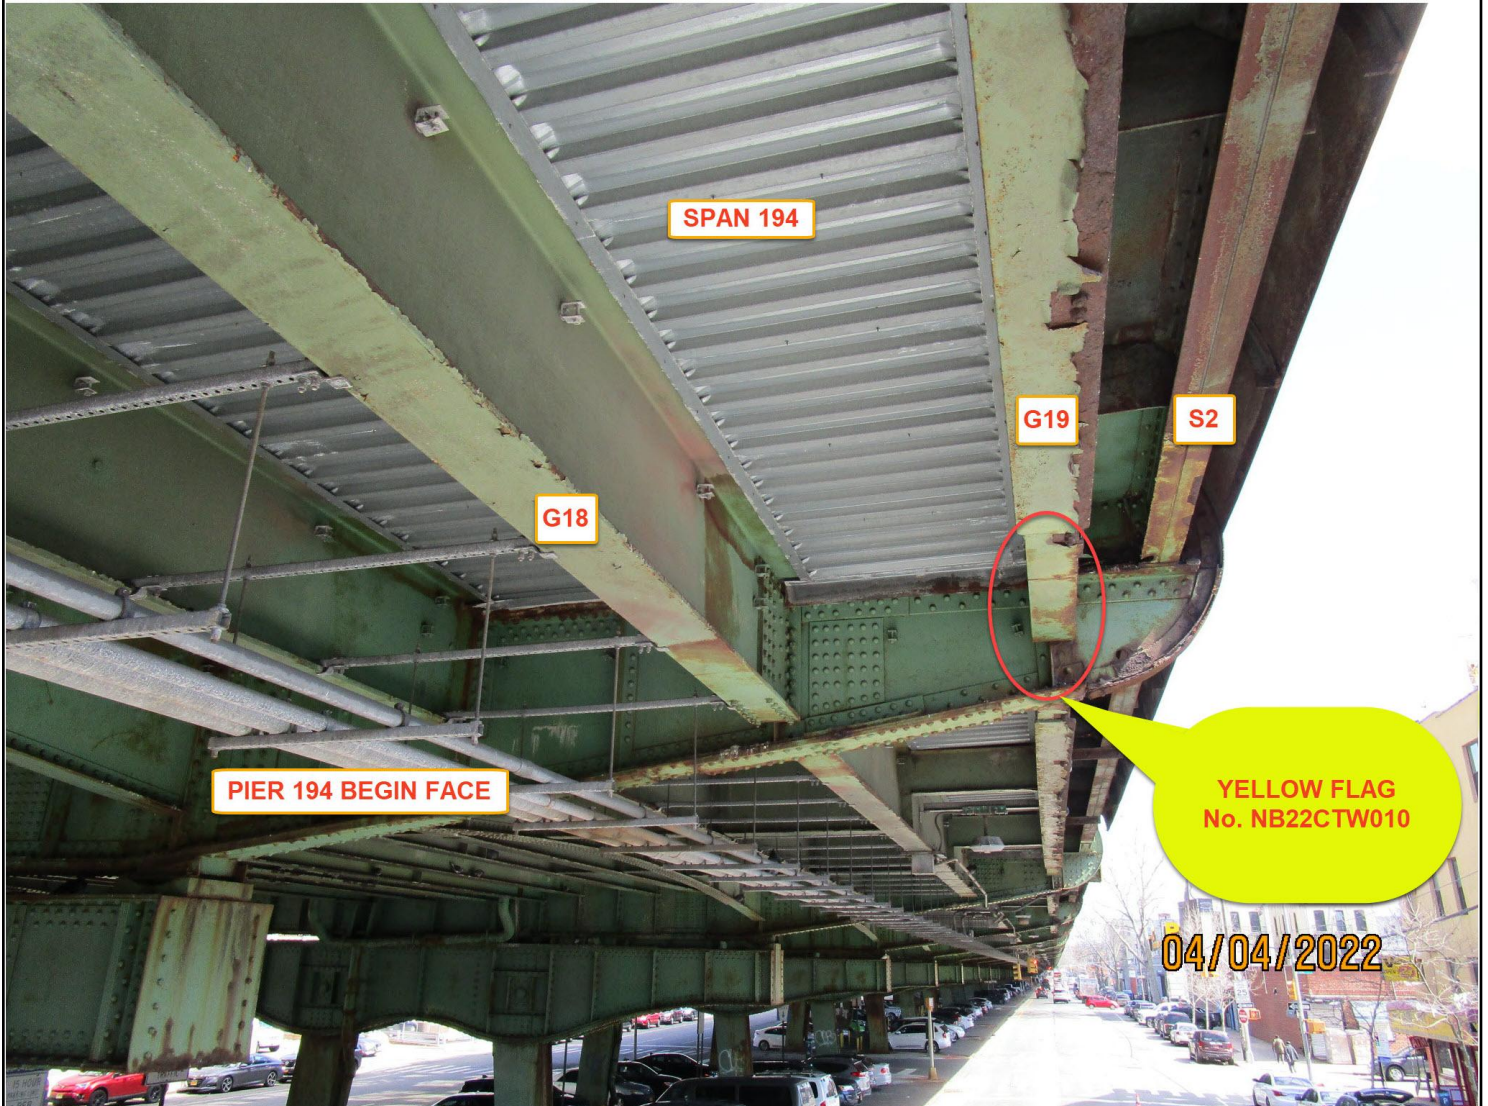
Photo Number: 1

Attachment Description: Span 194 G19 at Pier 194, Looking End: General view of the flagged location that exhibits severe corrosion and cracking in both connection angles of the girder to the pier cap.

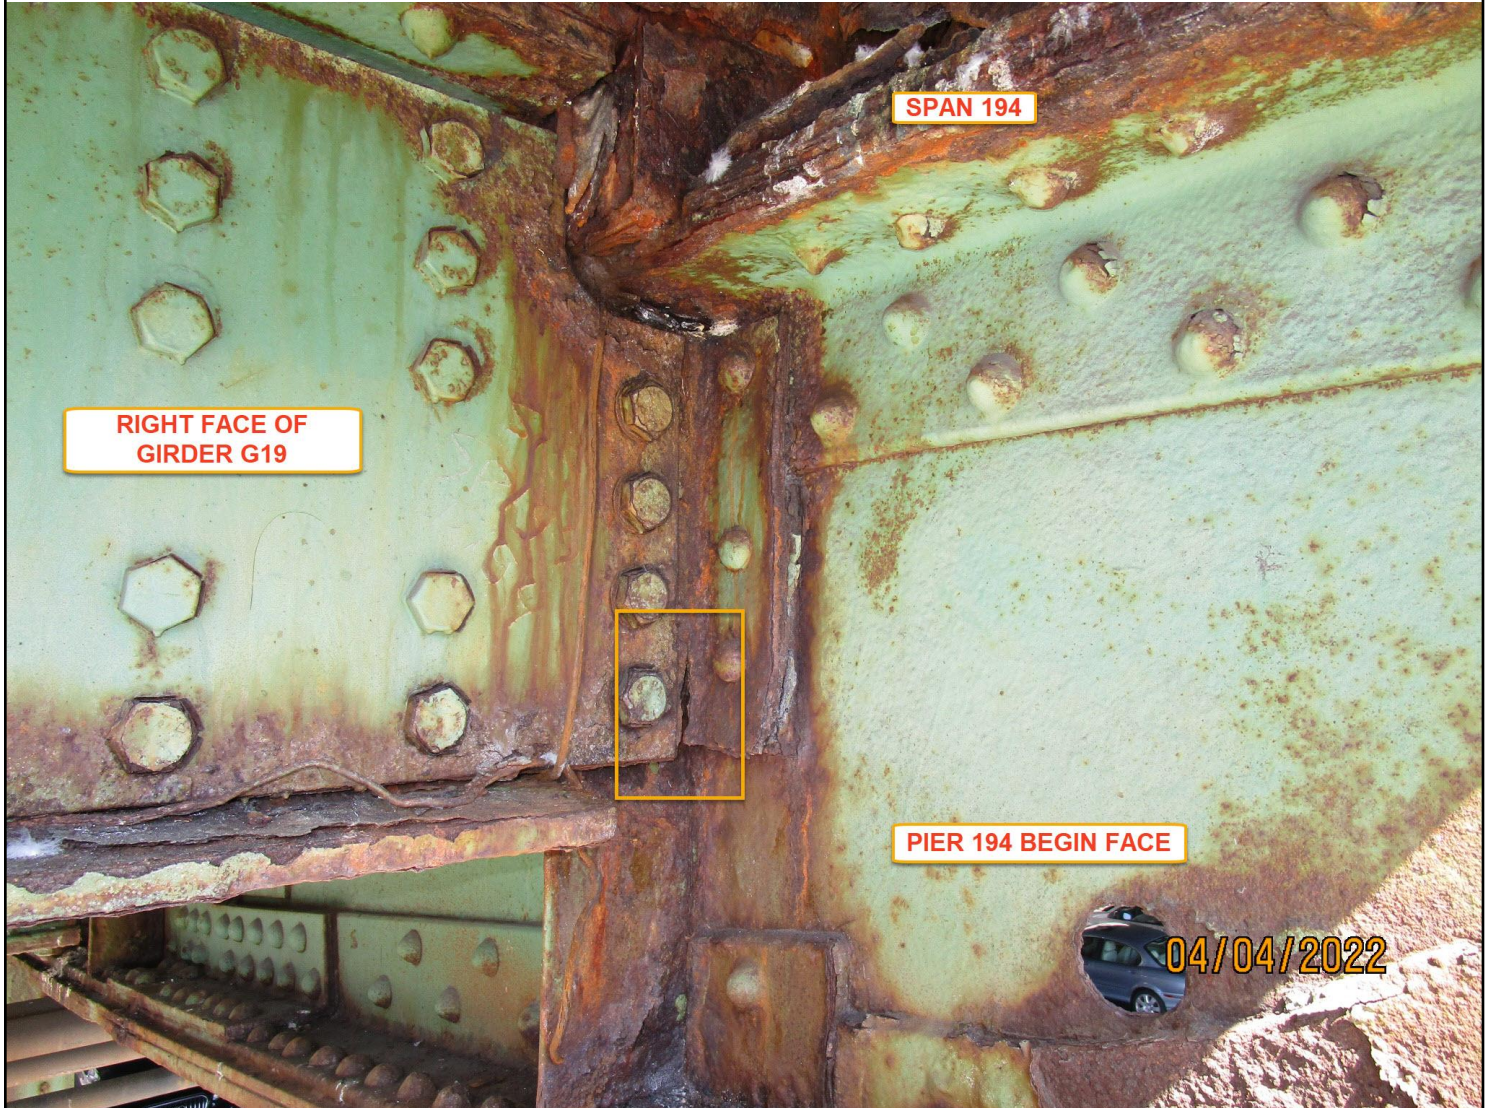
Photo Number: 2

Description: The right clip/connection angle of Girder G19 connection to the pier cap at Pier 194 exhibits a 3-1/4" (previously 3") long vertical crack x 1/4" (previously 1/8") wide at the lower fillet section. At the left side of Girder G19, the stiffener connection angle is heavily corroded and has a 4.5" L x 1/4" corrosion hole adjacent to the girder bottom flange connection (no change from the previous inspection).

Attachment Description: Span 194 G19 at Pier 194, Looking End-Left: General view of the flagged location showing severe corrosion/cracking in the lower fillet area of the girder connection angle, right side.

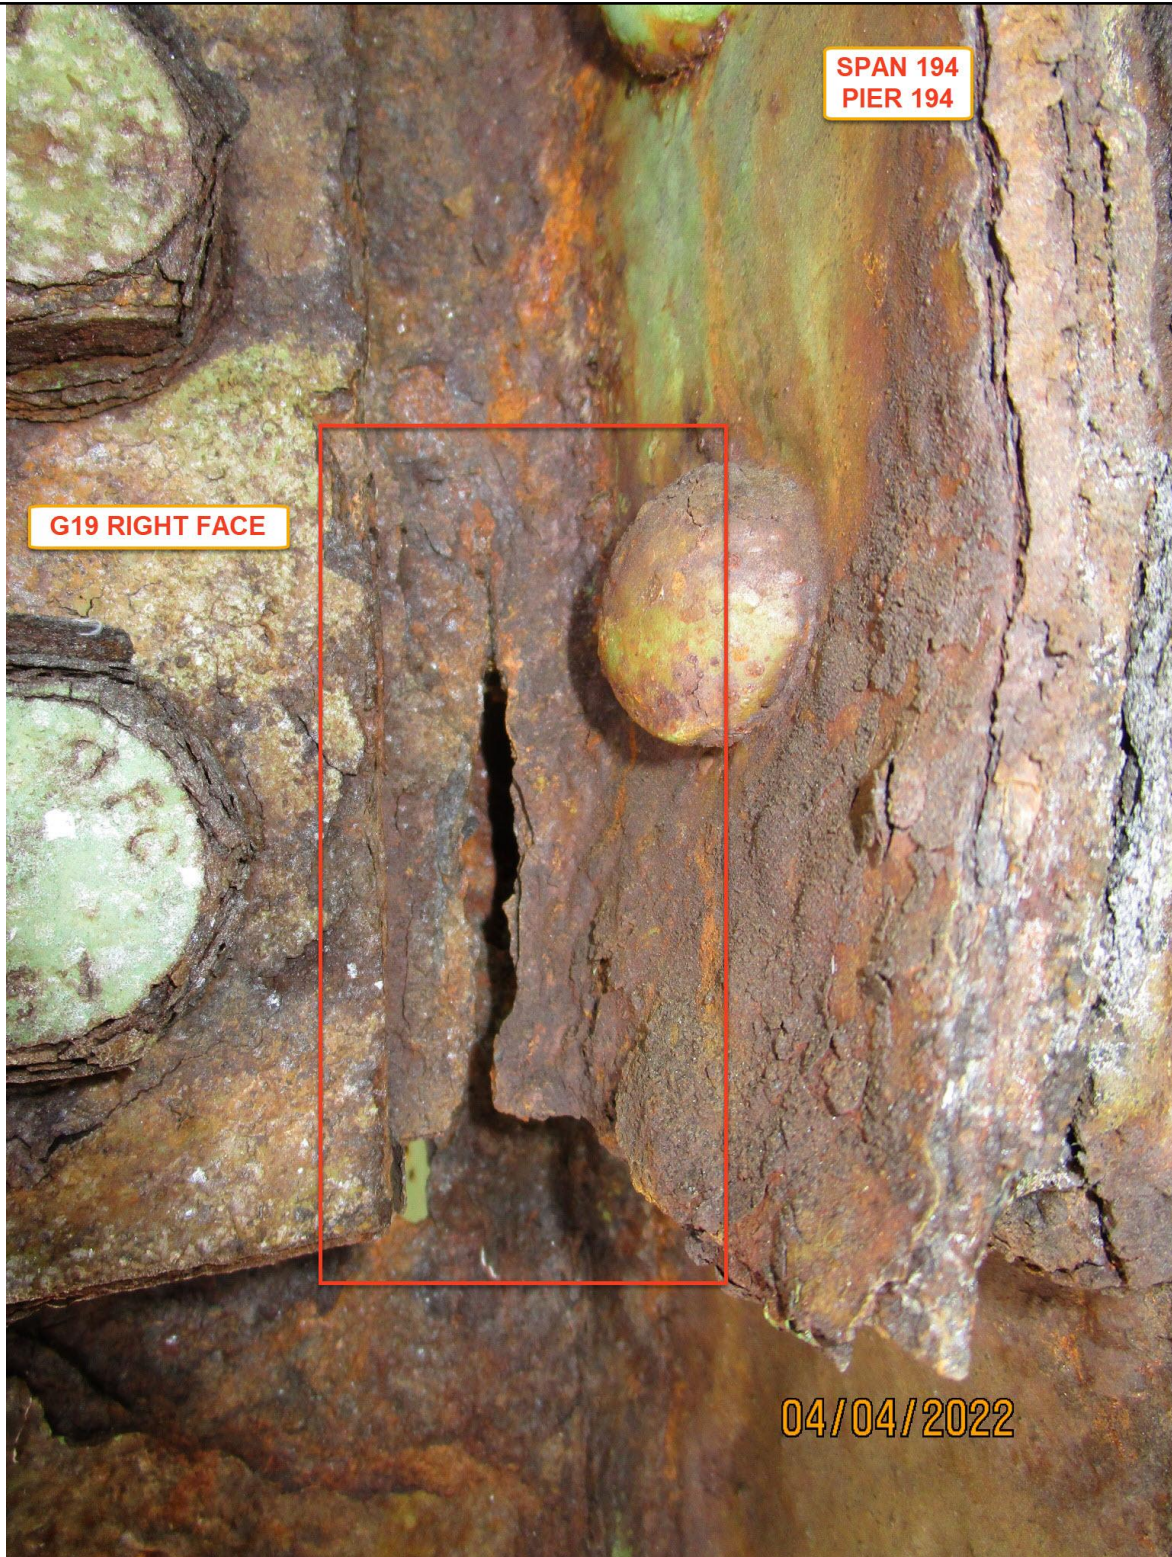
Photo Number: 3

Attachment Description: Span 194 G19 at Pier 194, Looking End-Left: Close-up view of the flagged location showing severe corrosion/cracking in the lower fillet area of the girder connection angle right side.

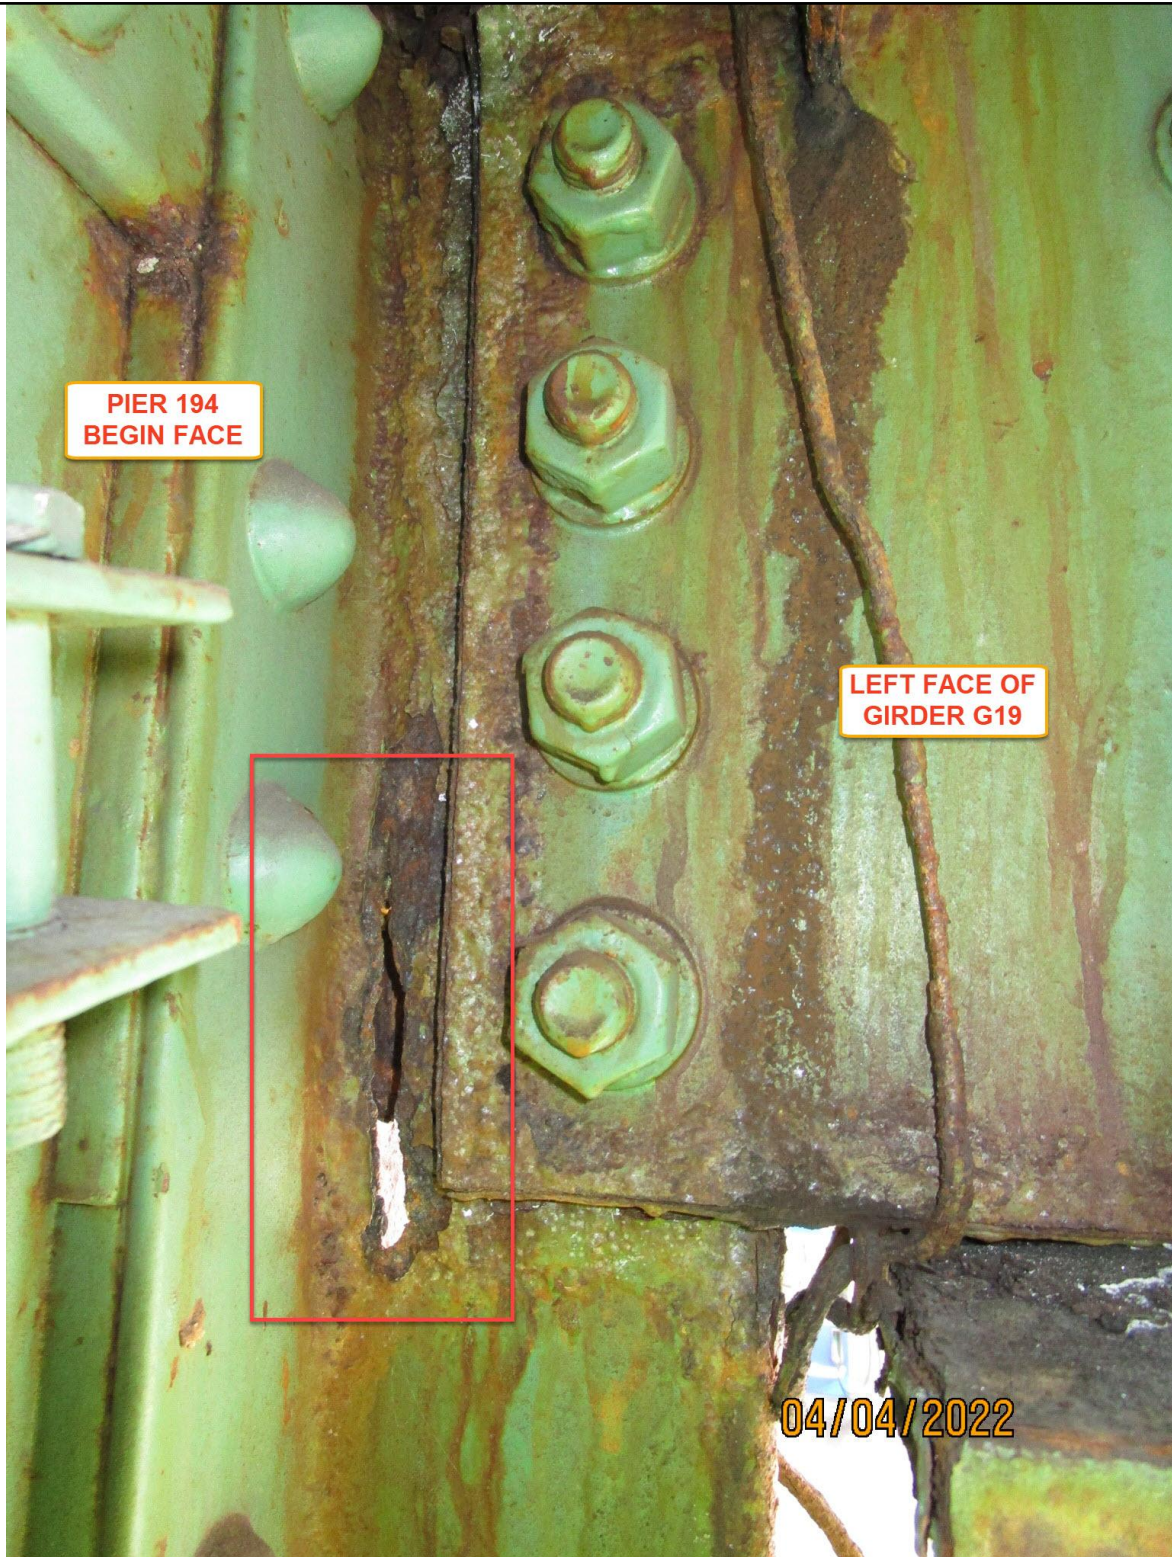
Photo Number: 4

Attachment Description: Span 194 G19 at Pier 194, Looking Right: General view of the flagged location showing severe corrosion/cracking in the lower fillet area of the girder connection angle, left side.

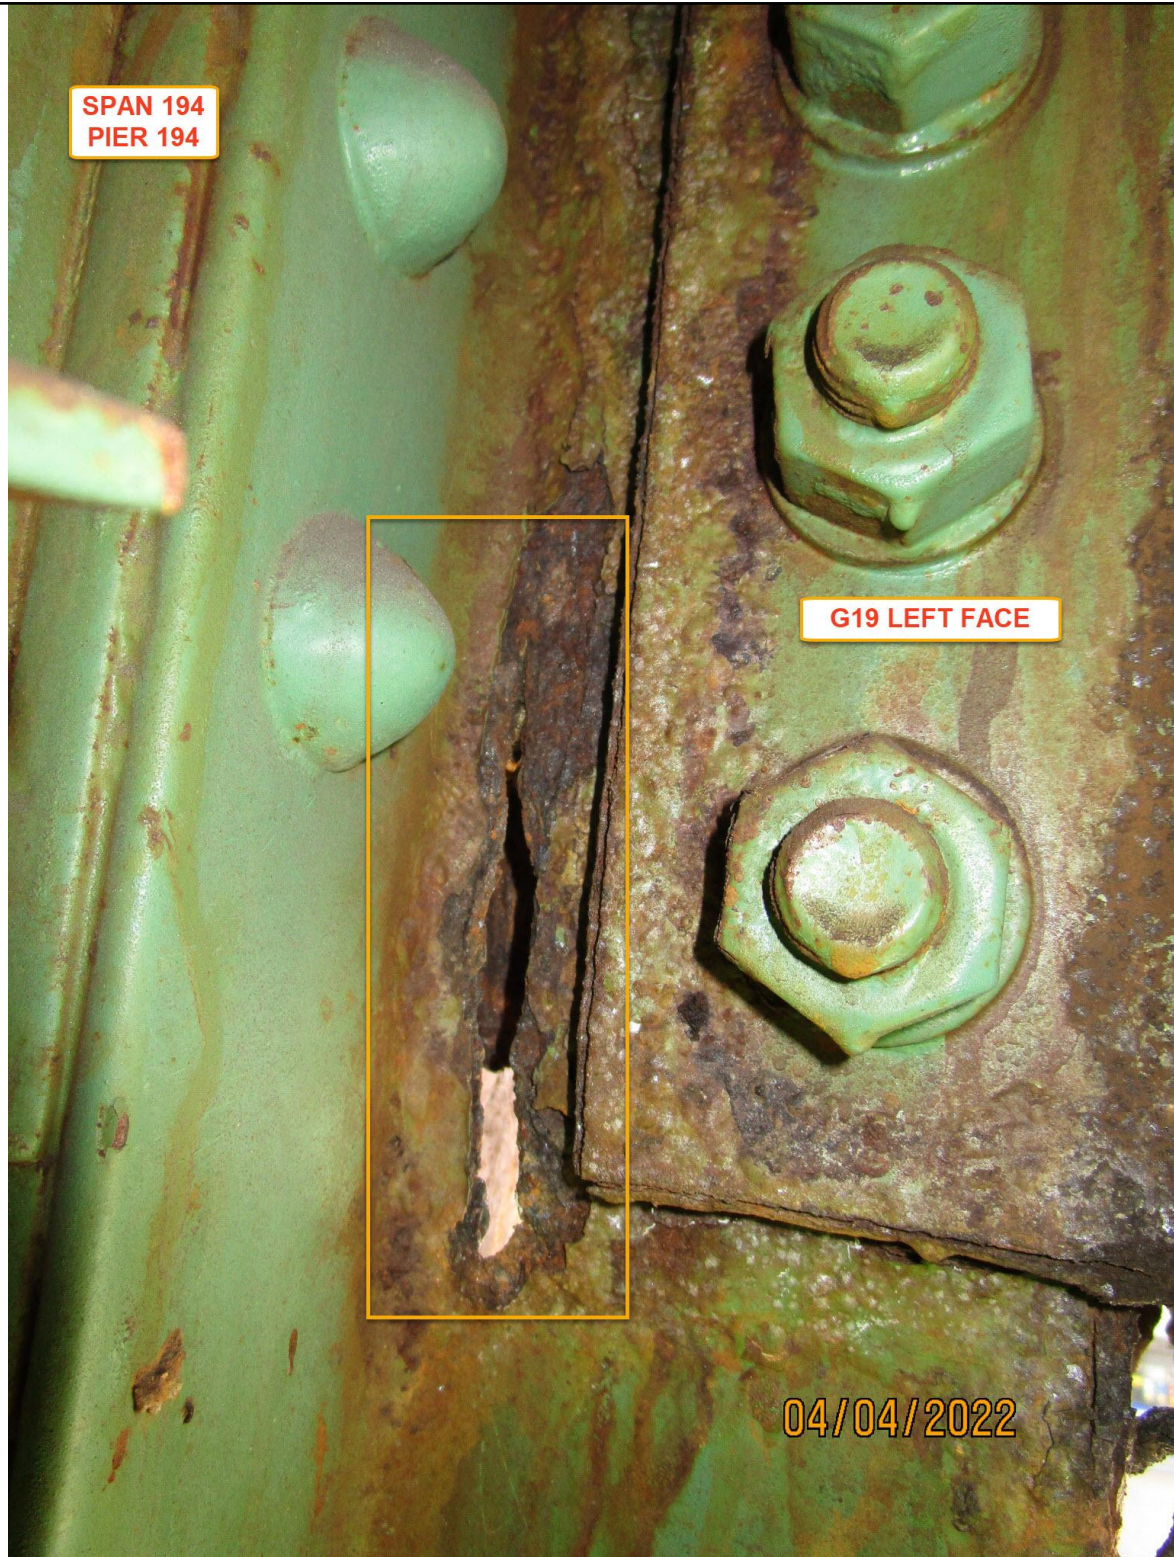
Photo Number: 5

Attachment Description: Span 194 G19 at Pier 194, Looking Right: Close-up view of the flagged location showing severe corrosion/cracking in the lower fillet area of the girder connection angle left side.

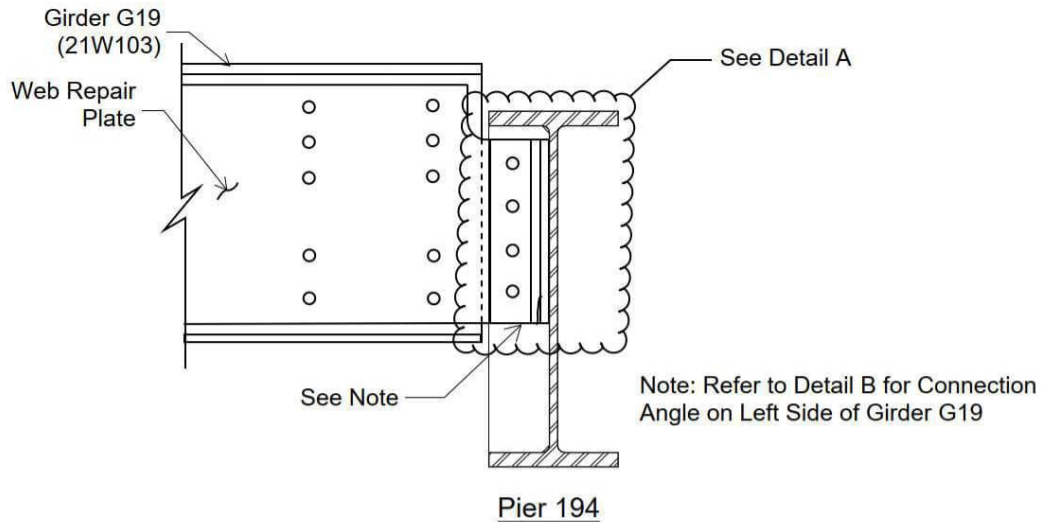
**SPAN 194, GIRDER G19 BEAM END AT PIER 194****(LOOKING LEFT)****N.T.S**

DETAIL - A
DETAILED VIEW OF BEAM END CONNECTION
SHOWING CRACK (LOOKING LEFT)
N.T.S

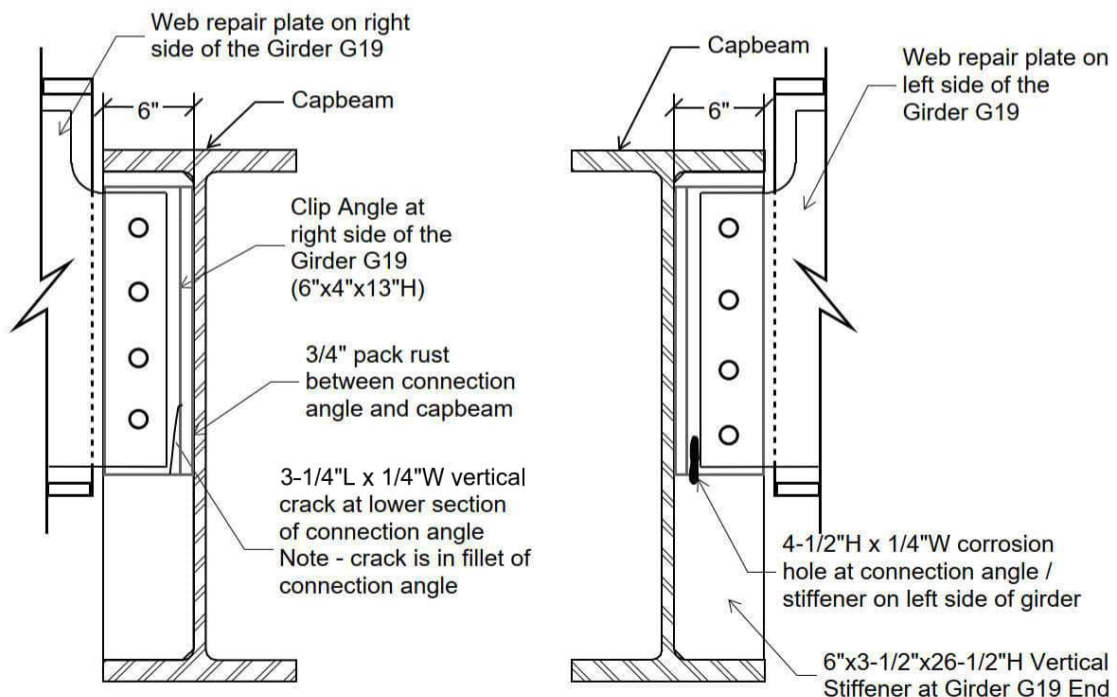
DETAIL - B
DETAILED VIEW OF BEAM END CONNECTION
SHOWING HOLE (LOOKING RIGHT)
N.T.S
